NWC TP, 4756

## ROCKET ASSISTED PROJECTILE (RAP) DEVELOPMENT PROGRAM

### Part 4. 5"/38 SAFETY TEST PROGRAM

**NAVAL WEAPONS CENTER**  
CHINA LAKE, CALIFORNIA \* JANUARY 1970

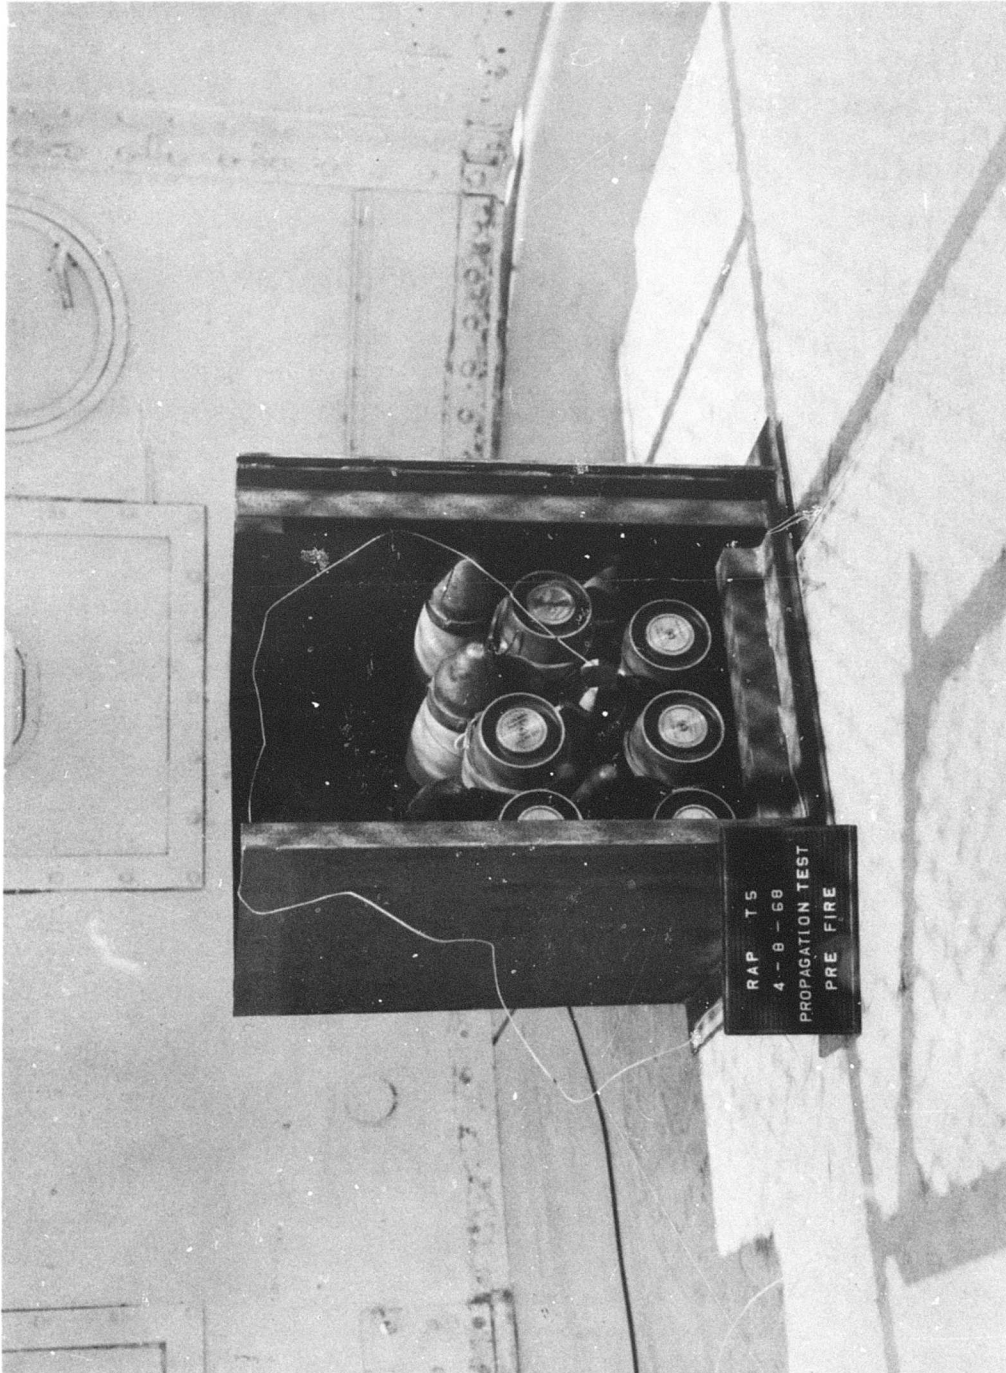
The 12 projectiles were then placed in the test fixture. Upon completion of loading, the fuze protector cap of projectile TM-12, the center projectile in the next to lowermost row, was removed and a 1-inch-diameter by 1-inch-long tetryl booster pellet and an HC-37 detonator placed in the fuze cavity. Figure 10 shows the arrangement of projectiles. The simulated steel batten was then set in place in the test fixture. Figure 11 shows the completed test setup. TM-12F was then detonated by applying a 117 vac pulse to the HC-37 detonator.

FIG. 10. Projectiles for Propagation Test Installed in Simulated Storage Bin. The detonator and booster charge are installed in the donor projectile (LHL 142887).

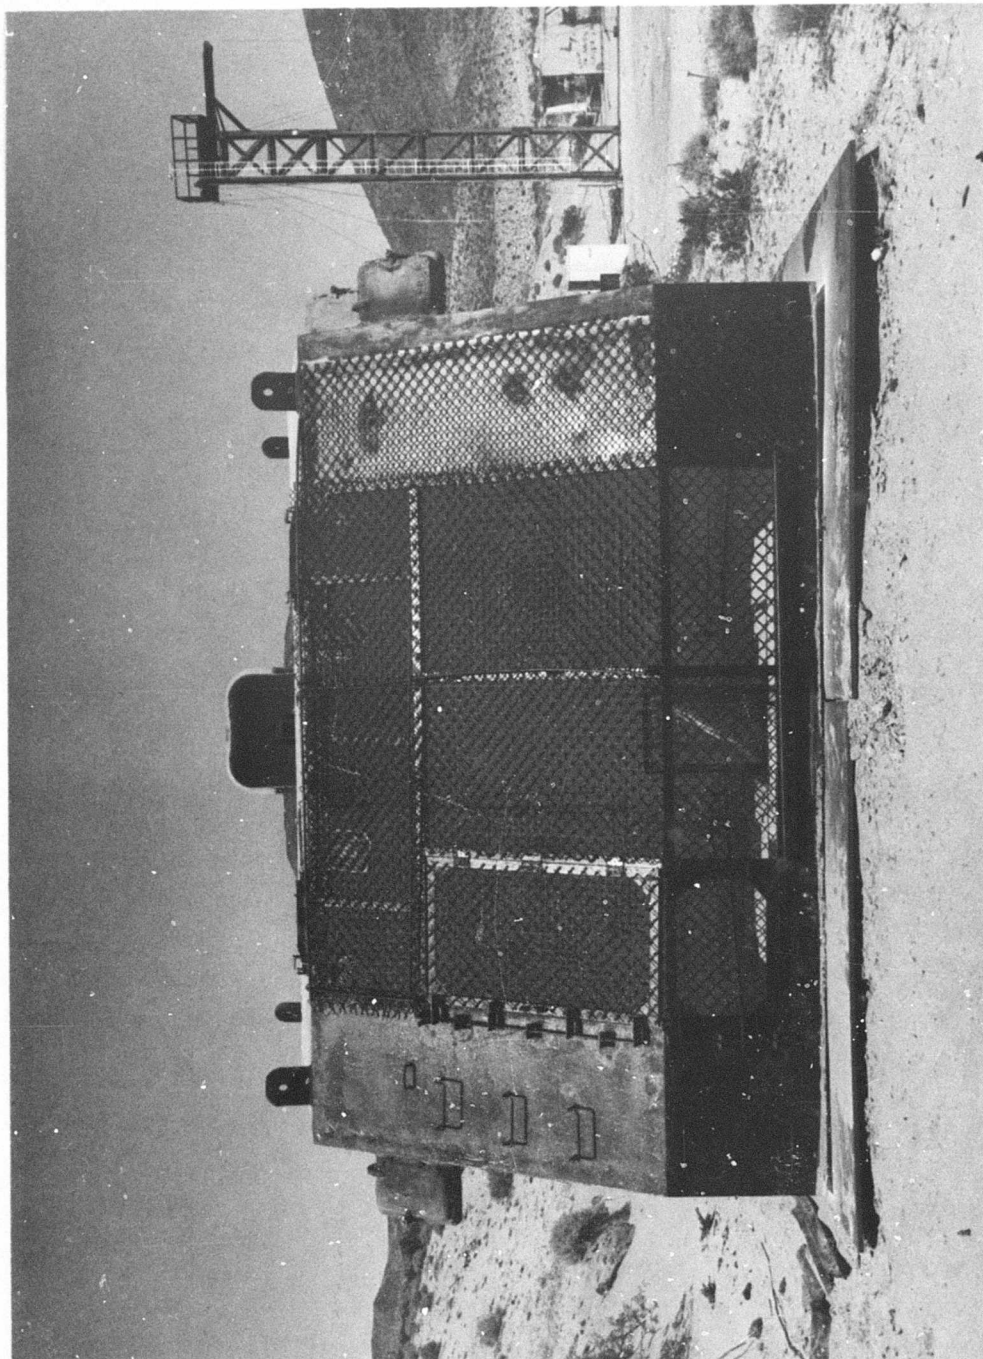
FIG. 11. Completed Setup for Propagation Test Prior to Detonation of Donor Projectile (LHL 142890).

Upon application of the firing pulse, all 12 projectiles appeared to detonate simultaneously. Visual inspection of the test site revealed the following:

1. The 5"/38 gun shield was completely destroyed. The side, front, rear, and top portions were propelled distances of 50 to 125 feet from ground zero. Figure 12 is an overall post-test view of the test site.

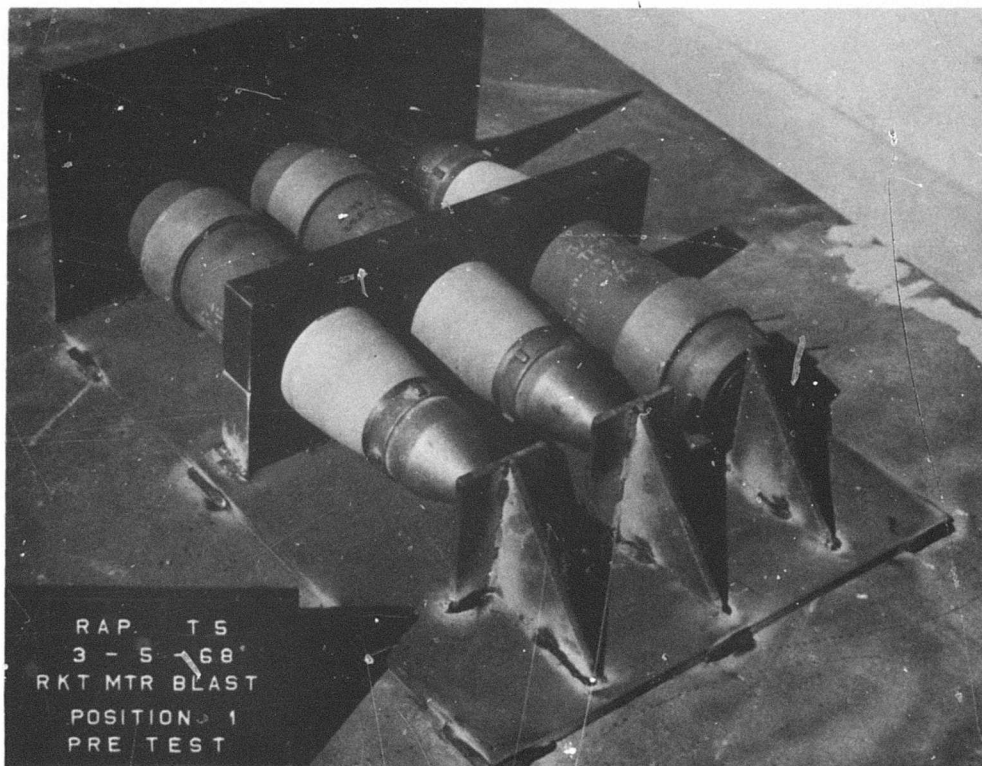
Test Position 1 was to simulate the effects of the flame impinging upon a standard batten or bulkhead in shipboard stowage and reflecting upon adjacent projectiles. Three all-up projectiles, TM-30F, TM-31F, and TM-34F, were utilized for this test. All projectiles were configured with a Mk 357 CVT Fuze and Adapter Assembly. The projectiles were placed in a three-place saddle block fixture welded to a fixed steel plate to prevent movement of the test fixture upon rocket motor ignition. Projectile TM-34F, the donor projectile, was placed in the center position with the base of the motor approximately 1 inch away from the deflector plate. The deflector plate was 1/4-inch mild steel. Projectile TM-30F, an acceptor projectile, was placed in the left outboard position with its base 1 inch from the deflector plate. Projectile TM-31F, also an acceptor, was placed in the right outboard position with the tip of the fuze protector cap 1 inch away from the deflector plate. The distance between the projectiles was 1 1/2 inches. Figure 13 shows the arrangement of projectiles.

FIG. 13. Setup for Rocket Motor Blast Test, Position 1.  
The donor projectile is in the center position (LHL 142821).

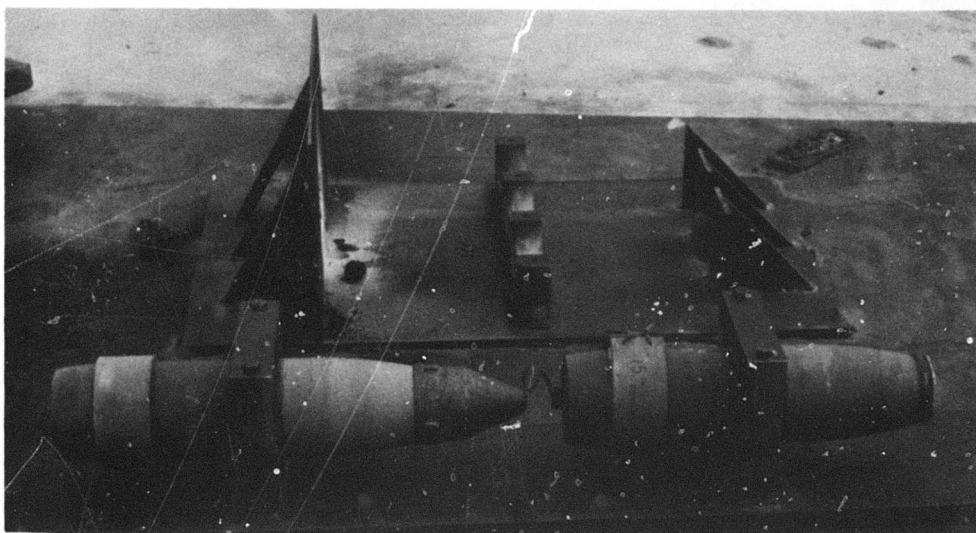
Test Position 2 was to simulate the effects of the rocket motor flame impinging directly upon the fuze of an adjacent projectile. Projectile TM-32F, the acceptor, was placed in the aft saddle block of a two-place tandem fixture welded to the steel plate. Projectile TM-35F, the donor, was secured in the forward saddle block with the base of the projectile 1 1/2 inches from the tip of the fuze protector cap of TM-32F (Fig. 14).

FIG. 14. Setup for Rocket Motor Blast Test, Position 2.  
The donor projectile is on the right (LHL 142827).

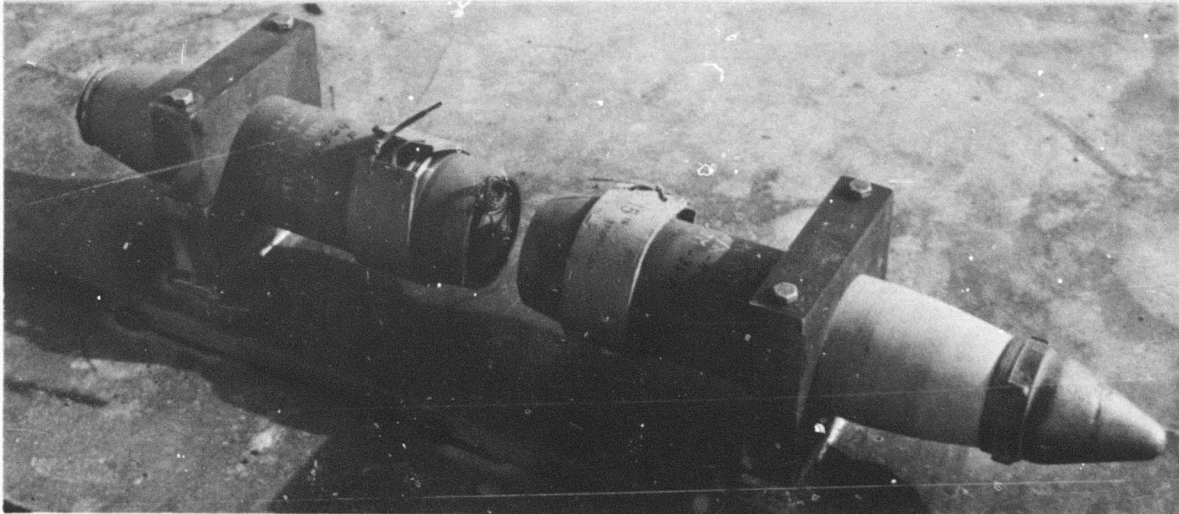
Test Position 3 was to simulate the effects of the rocket motor blast impinging upon the base of an adjacent projectile. Projectile TM-33F, the acceptor, was placed in the forward saddle block of a two-place tandem fixture and projectile TM-36F, the donor, placed in the aft saddle block (Fig. 15). The distance between the bases of the projectiles was 1 1/2 inches.

FIG. 15. Setup for Rocket Motor Blast Test, Position 3.  
The donor projectile is on the left (LHL 142820).
